DELAWARE COUNTY, NEW YORK  
INVENTORY NO. N.Y. 524

**PHASE I INSPECTION REPORT  
NATIONAL DAM SAFETY PROGRAM**

PHASE I INSPECTION REPORT  
NATIONAL DAM SAFETY PROGRAM  
REXMERE DAM  
I.D. No. NY 524  
#160A-3493  
DELAWARE RIVER BASIN  
DELAWARE COUNTY, NEW YORK

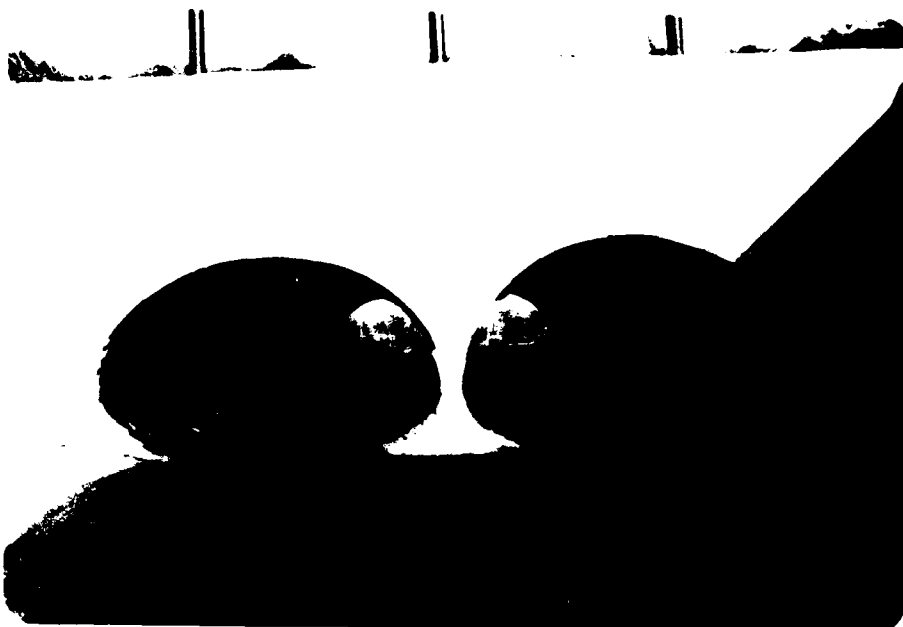
Other deficiencies observed were on the downstream portion of the spillway. The downstream headwall was cracked above and to the right (looking upstream) of the eastern pipe arch. Finally, there were three areas where the concrete and riprap at the end of the channel had been undermined, resulting in subsidence of the riprap. Water was entering these areas from the spillway channel and was flowing beneath these depressed sections.

Headwall at Outlet of Pipe-Arches - Note Cracks in Wall above Right Pipe-Arch

- 2 PIPE-ARCHES. CONCRETE & CONCRETED RIPRAP DISCHARGE CHANNEL.
- a. General SATISFACTORY - DOWNSTREAM HEADWALL AT EASTERN PIPE ARCH HAS 1 VERTICAL & 1 DIAGONAL CRACK ALONG ENTIRE FACE.
- b. Condition of Service Spillway BOTH PIPES BITUMINOUS COATED  
BOTH HAVE SOME COATING MISSING & DISCOLORATION & CORROSION IN THOSE SPOTS. BOTH PIPES HAVE AN INWARD BULGE NEAR THE CENTER. WESTERN PIPE ARCH HAS A JOINT SEPARATION (1" x 12") AT THE CROWN IN THE UPSTREAM 1/3 OF PIPE. EASTERN PIPE ARCH HAS SEVERAL JOINT SEPARATIONS ALONG INVERT WHICH HAVE BEEN PLUGGED WITH JOINT SEALER.

- e. A monitoring program should be established to periodically inspect the cracks on the spillway outlet headwall as well as the bulges on the pipe-arches and determine whether these conditions are worsening.
- f. Surface irregularities on the crest should be repaired and measures should be taken to prevent unnecessary traffic from crossing the crest.
- g. Minor deficiencies with the spillway pipe-arches such as the joint separations and the spots where the bituminous coating has worn off should be monitored and repaired if the conditions become more serious.
- h. The reservoir drain should be made operable. The valve box for the reservoir drain should be repaired. The major defects which must be addressed are the deterioration of the concrete on the box and the fact that the box is full of water.
- i. An emergency action plan for the dam should be developed.
